**DEPARTMENT OF TRANSPORTATION**

Contract #: 04-0120F4Cty: SF/ALA Rte: 80 PM: 13.2/13.9File #: 69.28**WELDING INSPECTION REPORT****Resident Engineer:**Pursell, Gary**Address:** 333 Burma Road**City:** Oakland, CA 94607**Report No:** WIR-010399**Date Inspected:** 16-Nov-2009**Project Name:** SAS Superstructure**OSM Arrival Time:** 700**Prime Contractor:** American Bridge/Fluor Enterprises, a JV**OSM Departure Time:** 1900**Contractor:** Zhenhua Port Machinery Company, Ltd (ZPMC), Changxing Island **Location:** Shanghai, China**CWI Name:** Guo Yan Fei**CWI Present:** Yes No**Inspected CWI report:** Yes No N/A**Rod Oven in Use:** Yes No N/A**Electrode to specification:** Yes No N/A**Weld Procedures Followed:** Yes No N/A**Qualified Welders:** Yes No N/A**Verified Joint Fit-up:** Yes No N/A**Approved Drawings:** Yes No N/A**Approved WPS:** Yes No N/A**Delayed / Cancelled:** Yes No N/A**Bridge No:** 34-0006**Component:** OBG Crossbeams**Summary of Items Observed:**

**OBG CROSS BEAM CB9**

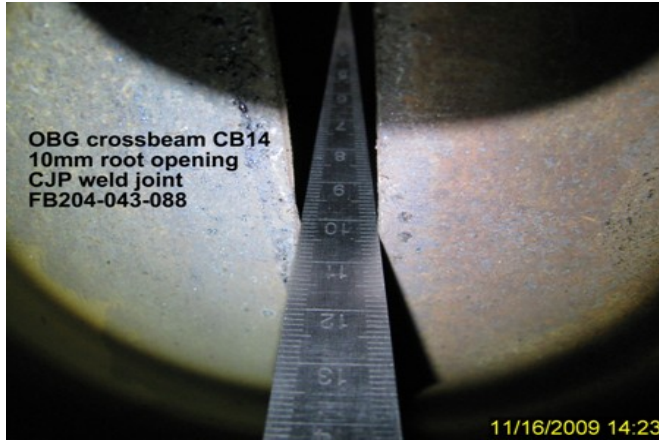
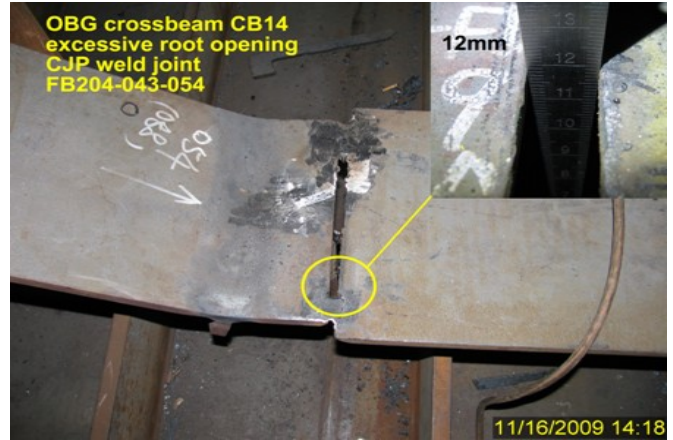
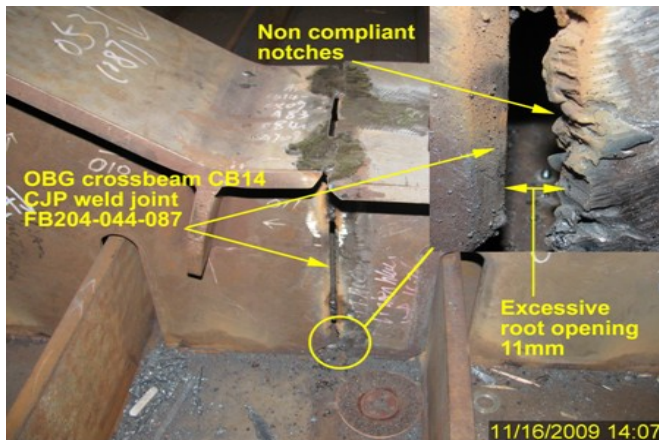
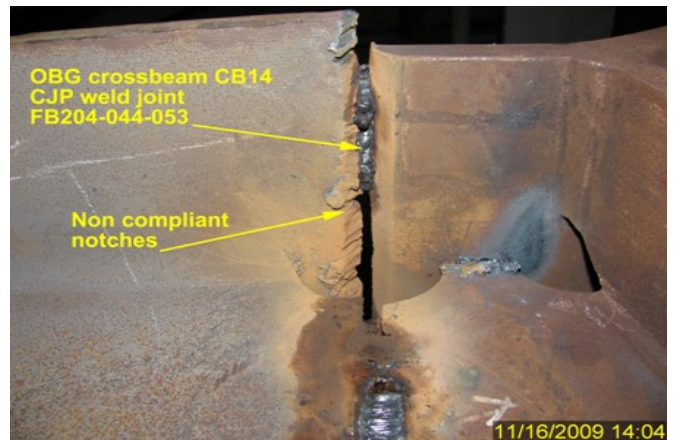
During random in process inspection of weld joint fit up this QA observed weld joint preparations and root openings that did not appear to comply with the contract documents. 5mm is the maximum root opening allowed for Complete Joint Penetration (CJP) welds and the cut edges to be welded shall be free of notches and other injurious defects that may affect the quality of the weld. The following is a list of the joint numbers and discrepancies observed:

1. FB204-044-053; root opening = 10mm, cut edge of one bevel exhibited excessive notches. (See attached photos)
2. FB204-044-087; root opening = 11mm, cut edge of one bevel exhibited excessive notches. (See attached photos)
3. FB204-043-088; root opening = 10mm (See attached photos)
4. FB204-043-054; root opening = 12mm (See attached photos)
5. FB204-042-054; root opening = 10mm
6. FB204-041-054; root opening = 9mm

ZPMC QC inspector and ABF QA inspector in this bay are aware of these discrepancies and informed this QA that the weld joints would be repaired prior to welding. The attached photos concerning these joints are for the purpose of capturing the in-process workmanship being performed on this crossbeam.
